SMITHSONIAN INSTITUTION
BUREAU OF AMERICAN ETHNOLOGY
BULLETIN 121

ARCHEOLOGICAL REMAINS IN THE
WHITEWATER DISTRICT
EASTERN ARIZONA

PART I. HOUSE TYPES

By FRANK H. H. ROBERTS, JR.

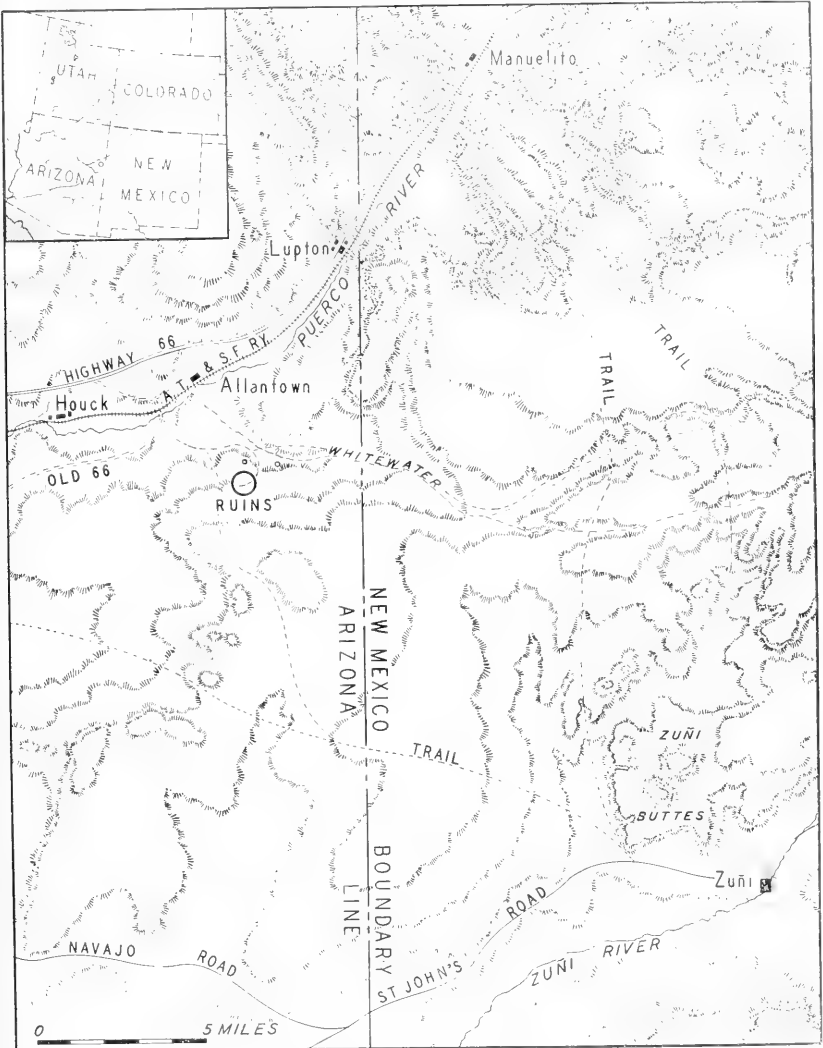
Map of the Whitewater district. Inset shows location of ruins with respect to general southwestern area.

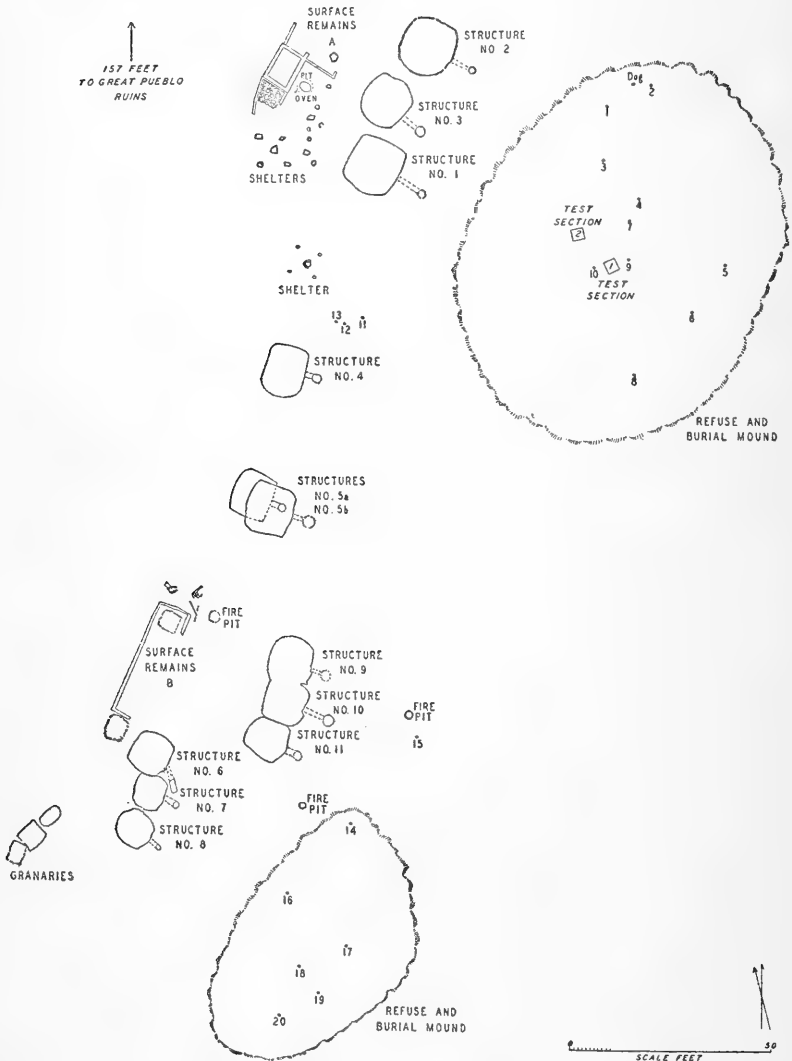
FIGURE 1.—Group 1 pit and surface remains. Numbered dots indicate location of burials.

The pit remains at the main site were associated with some surface ruins and all features were investigated as the work progressed. The pits were numbered consecutively, although they occurred in two main groups. The first cluster was located south of the mounds enclosing the Great Pueblo ruins and consisted of 12 pits, a pit oven, 4 brush shelters, and the remains of 2 surface masonry structures (fig. 1). The latter appeared at a later stage than some of the pits, but the oven and several of the brush shelters apparently were part of the older horizon. The second main group was located north of the large stone ruins and included 6 pits, some surface remains, and a dance court (fig. 25).

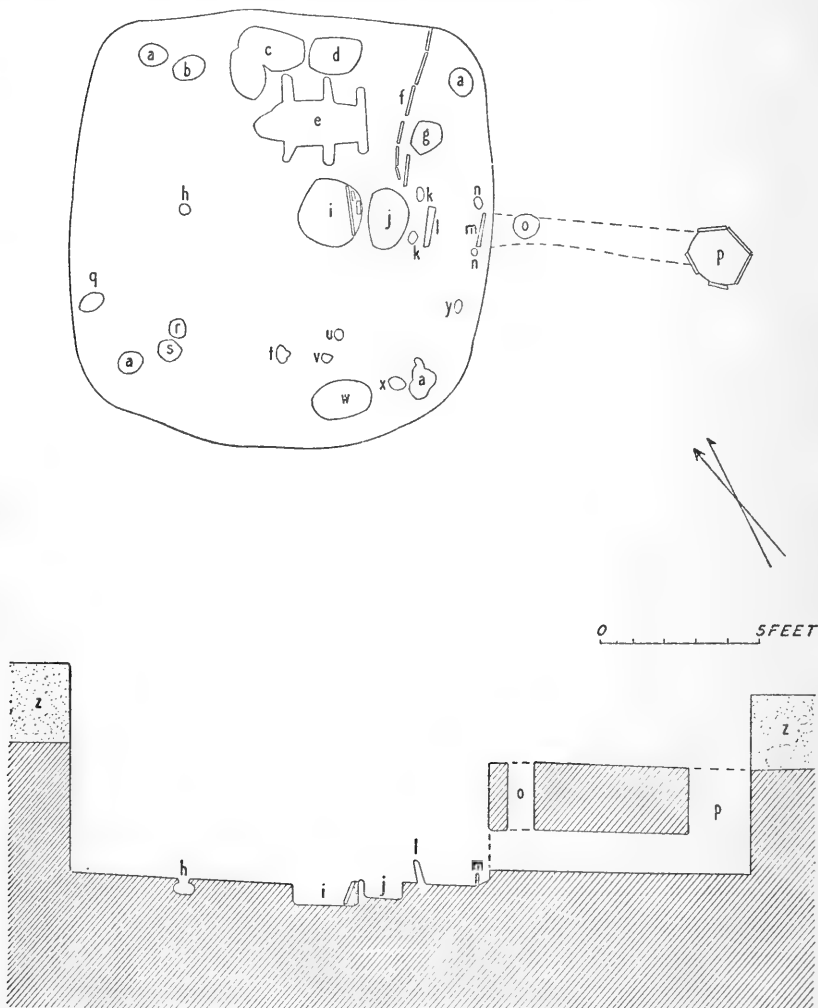
FIGURE 2.—Structure 1. *a*, holes for support posts; *b*, *c*, and *d*, storage basins; *e*, basin in floor; *f*, wall forming compartment; *g*, basin in floor; *h*, sipapu; *i*, fire pit; *j*, ash pit; *k*, ends of ladder poles; *l*, deflector; *m*, stone to protect ventilator opening; *n*, pole placement; *o*, small shaft in ventilator; *p*, main ventilator shaft; *q*, pot rest or storage hole; *r*, *s*, *t*, *u*, *v*, *w*, *x*, and *y*, storage holes and basin; *z*, sand accumulation above old ground level.

The larger basin-like depressions (fig. 2, *c*, *d*, *w*) possibly served as places in which baskets or jars were set, although there was no indication that such had been the case. What function the curiously shaped depression *e* may have been intended to fulfill is a question for which no answer has been found. At the time when the remains were excavated a small pitcher of the culinary variety of pottery was sitting in the end toward the ventilator side of the room. Several who saw the house suggested that loom sticks may have been placed across the depression in the arm-like projections at each side of the central portion. In view of weaving practices in general, as they are known throughout the Southwest, this does not seem to be a good explanation. There was nothing about the depression itself to furnish a clue.

The hole marked *h*, figure 2, corresponds in its general size and position to similar ones found in most pit houses and in many present-day kivas. In the kivas or ceremonial chambers the feature is called the sipapu, because the modern Pueblos use that name or a close variation of it to designate the hole. According to them it symbolizes the mythical place of emergence through which their ancestors are supposed to have passed in their journey from the inner portions of the earth, where they were created, to the surface of the world upon which they now live. Whether a similar interpretation was made in the past or not is a matter of conjecture. The belief is so firmly implanted in Pueblo mythology, however, that it may with considerable justification be assumed that the prehistoric people regarded the feature in the same light. A further support for this theory is derived from

seven stones forming a bin-like enclosure at the southeast corner of the room (fig. 2, *f*; pl. 3, *a*). One of the typical interior elements in Modified Basket Maker houses consists of a low wall of stone slabs separating the ventilator or, as was the case in many of the dwellings of that period, the entrance side of the chamber from the rest of the room. Sometimes the partition wall extended entirely across from support post to support post. Then again it was broken by a doorway in front of the passage opening into the wall. Occasionally a house is found that only has corner bins at that side of the room.²⁰ The enclosure in one corner of No. 1 is very suggestive of the more complete examples found in the Chaco Canyon houses and possibly represents a survival in the houses of a later day of a characteristic common during a previous stage in house development. The purpose of such compartments is not known. Two metates or grinding stones were found in the present example. This would suggest that the enclosure may have served as a mealing bin for the house. On the other hand it is quite possible that the stones were placed there during intervals when they were not in use, since one was leaning against the partition and the other against the wall. The bin may have served solely in the capacity of a storage place. Firewood, jars containing surplus food and other items connected with the daily life of the people could have been placed there where they would not interfere with the general trend of affairs in the main part of the structure. Somewhat comparable enclosures in the earth lodges of some of the Plains Indians, dwellings which in many ways bear a strong resemblance to the pit houses of the Southwest, despite the fact that they were largely surface structures, were employed for storing the supply of firewood in winter.²¹

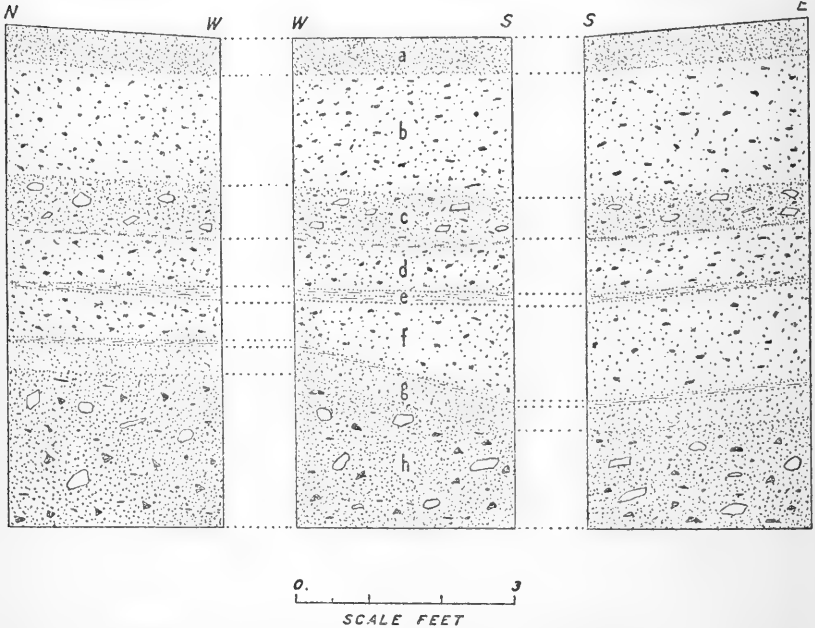
FIGURE 3.—Pillar left from fill in structure 1. N, W, S, and E, indicate north, west, south, and east corners. *a* to *h*, Strata in fill.

The second stratum (fig. 3, *b*) was considerably thicker than the first. It was 1 foot 6 inches (45.72 cm) from top to bottom. The main content was blow sand and ashes with some charcoal. Toward the lower half there was a marked increase in the number of potsherds present. In fact there was only one other layer in the entire pillar which contained more. This would suggest that there was considerable activity around the site at that time and the remains of many broken vessels found their way into the abandoned pit. The stratum did not give distinct evidence at this point of having typical refuse material in it and it does not seem that it can be attributed to house sweepings and other waste matter being dumped there. Rather would the character of the fill at this point suggest a more or less natural gravitation of objects into a depression.

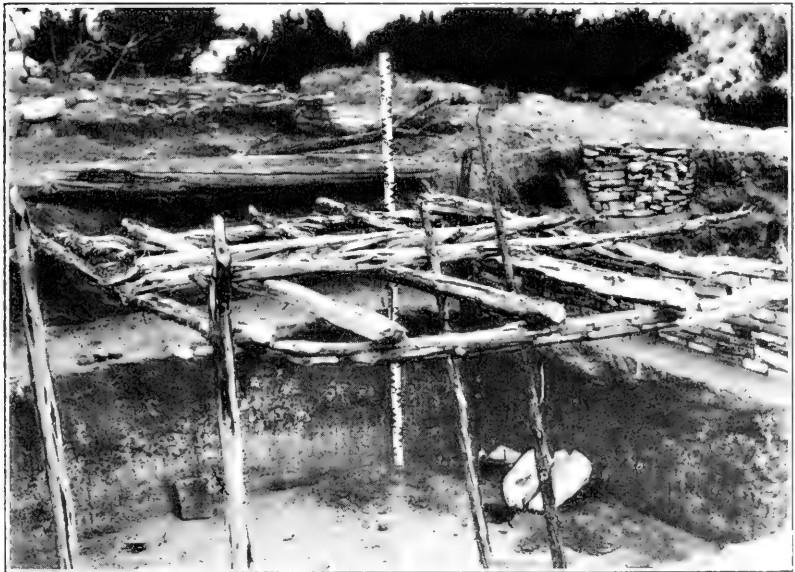
b. Main framework for restoration of structure 1.

The preliminary framework of upright posts and beams for the flat portion of the roof is shown in plate 3, *b*. The sloping side poles of the superstructure were then put in place and covered with brush and cedar bark as illustrated by plate 4, *a*. The hole was then covered with earth and took on the appearance of a low, flat mound (pl. 4, *b*). A view of one corner of the completed interior is illustrated by plate 5, *a*. The weathering qualities of such a roof were well tested by the winter of 1931-32 when unusually heavy rains and snows fell throughout the district. For a period of several weeks more than 3 feet (91.44 cm) of snow covered the house. Only a small amount of moisture penetrated to the interior during the melting period and a slight amount of repair was all that was necessary in the late spring of 1932. Had the structure been occupied and the usual amount of upkeep provided by the tenants, it would have come through the winter with practically no damage.

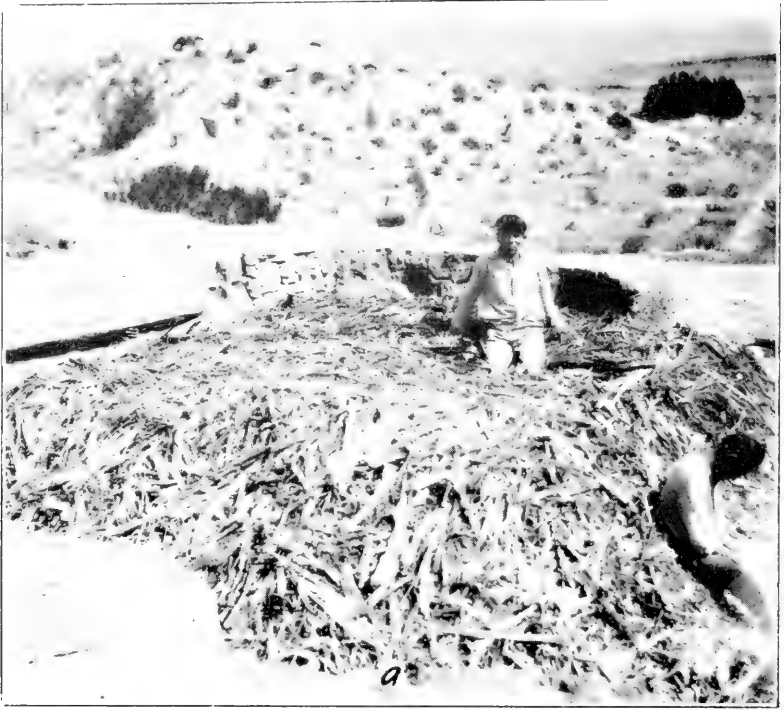
a. Brush-and-bark covering over framework, restoration of structure 1.

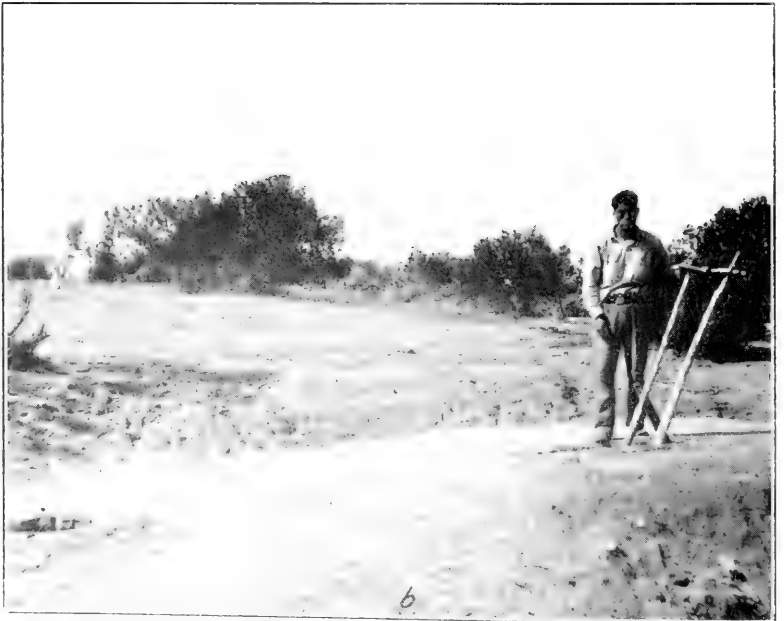
b. Completed structure showing rounding dome and smoke hole-hatchway entrance.

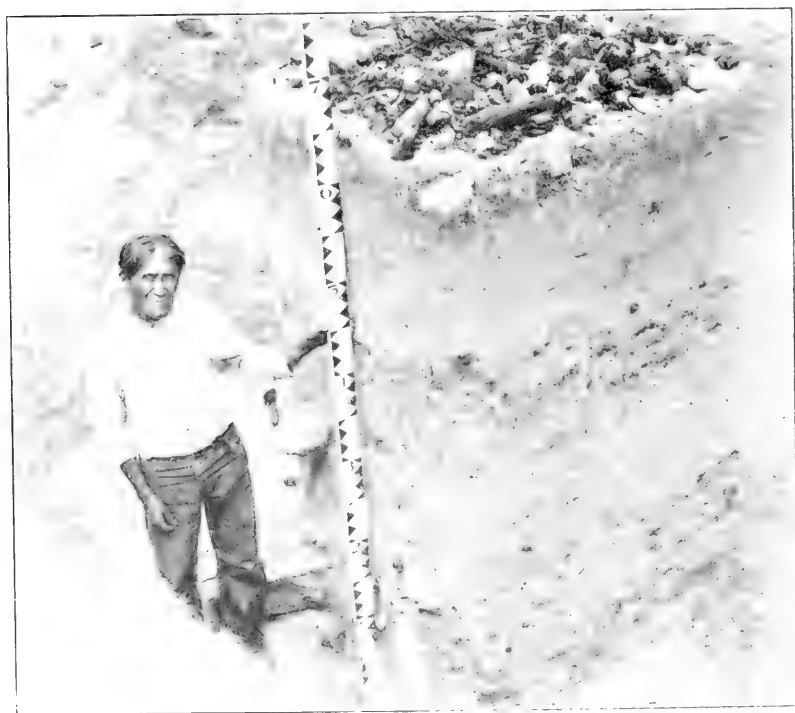
b. Pillar left in excavating pit, structure 1.

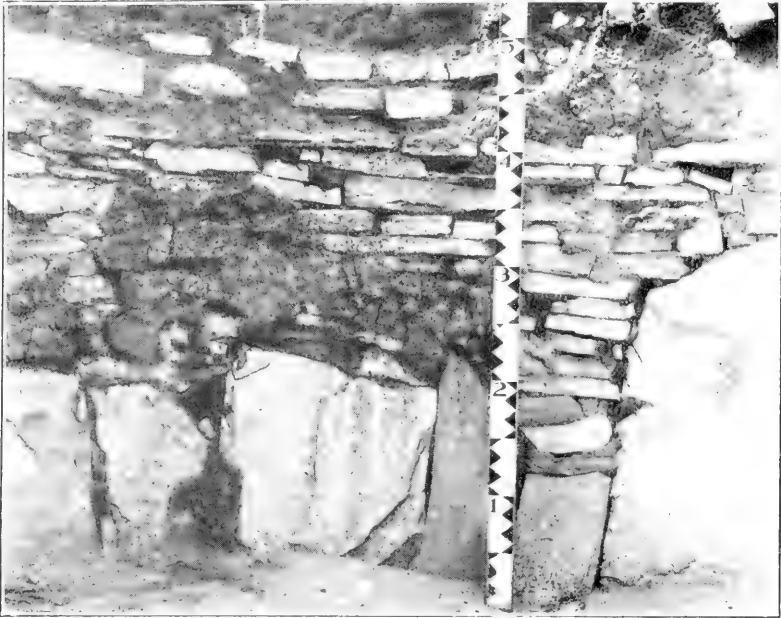
a. Masonry wall resting on slab foundation.

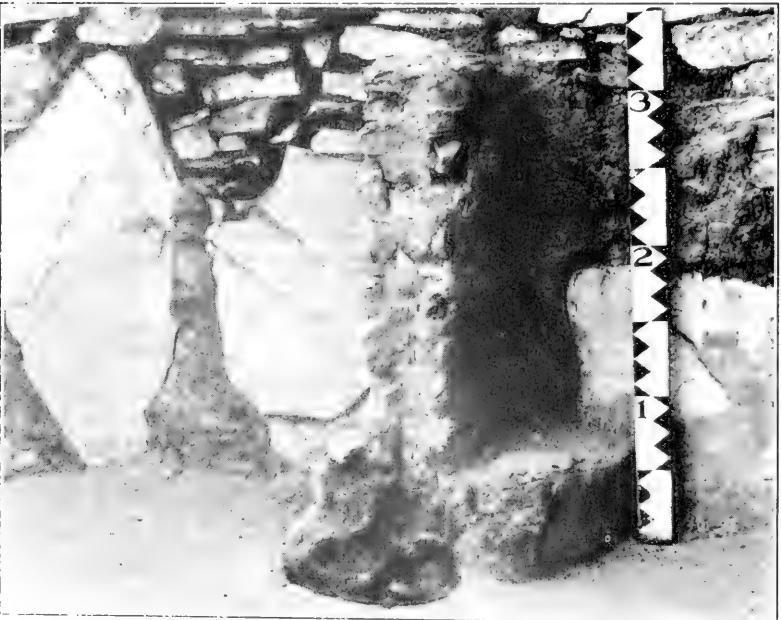
b. Pilaster in structure 2.

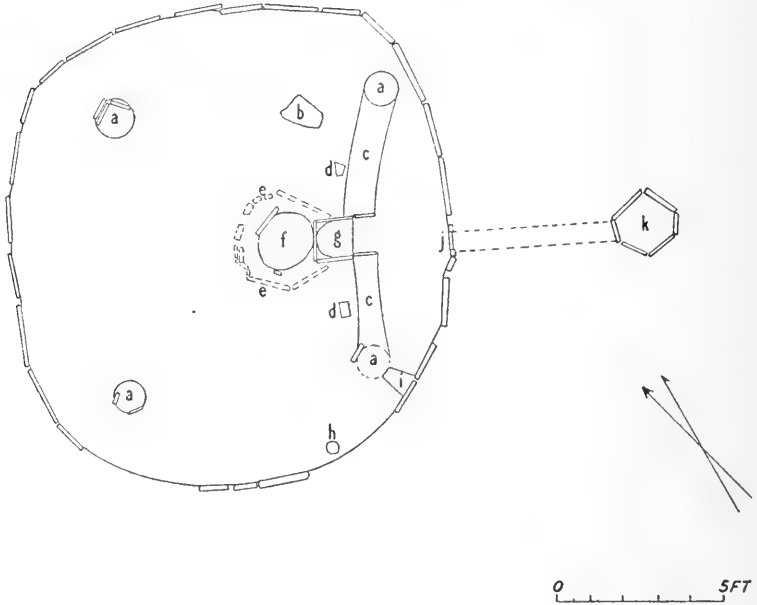
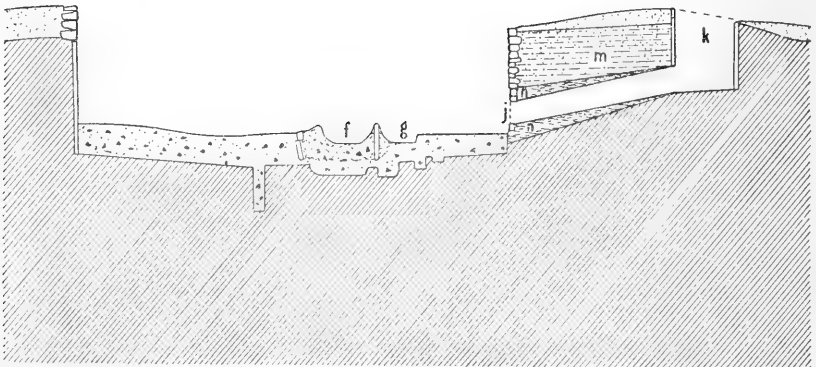
FIGURE 4.—Structure 2. *a*, holes for superstructure posts; *b*, stone embedded in floor; *c*, compartment walls; *d*, stone posts; *e*, subfloor slabs reinforcing fire pit; *f*, fire pit; *g*, ladder box and ash pit; *h*, storage hole; *i*, pilaster behind support post; *j*, ventilator opening; *k*, ventilator shaft; *m*, fill over ventilator passage; *n*, plaster used to reduce passage size.

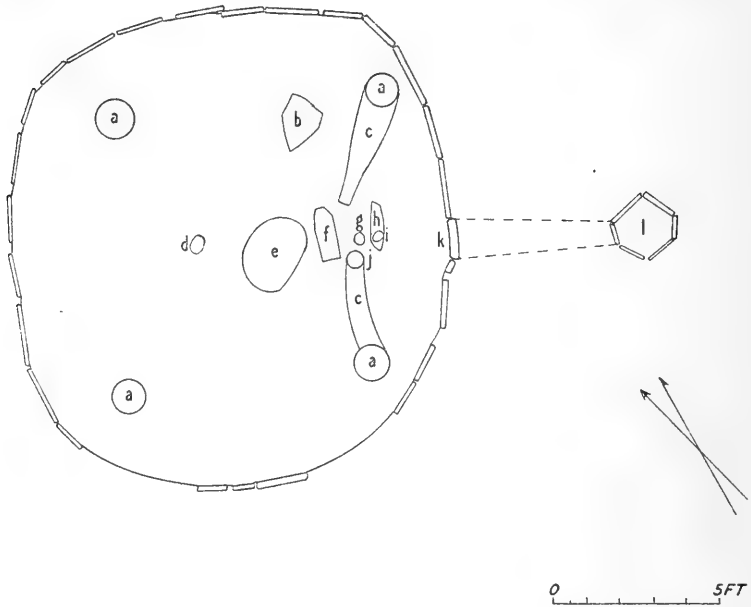
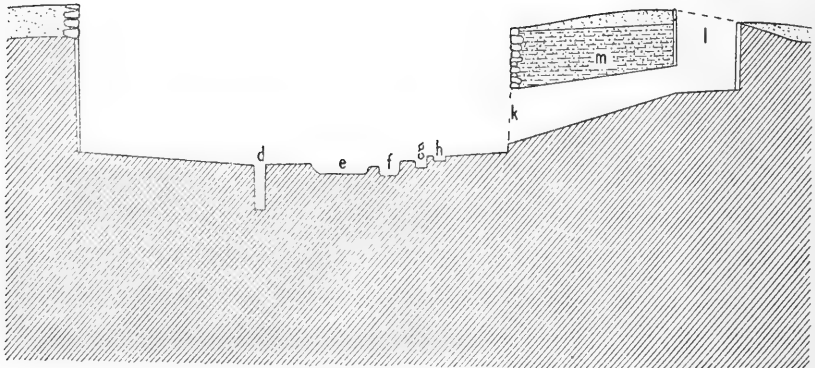
FIGURE 5.—Structure 2a. *a*, holes for main support posts; *b*, stone embedded in floor; *c*, adobe ridges forming compartment; *d*, sipapu; *e*, fire pit; *f*, ladder box; *g*, storage hole; *h*, groove in floor; *i*, pole mold; *j*, storage pit; *k*, ventilator opening; *l*, ventilator shaft; *m*, fill above ventilator passage.

feature was present that was lacking in the later level, namely, a sipapu (fig. 5, *d*). In addition there was a second trench, similar to the ladder pit, in the floor just inside the compartment (fig. 5, *h*).

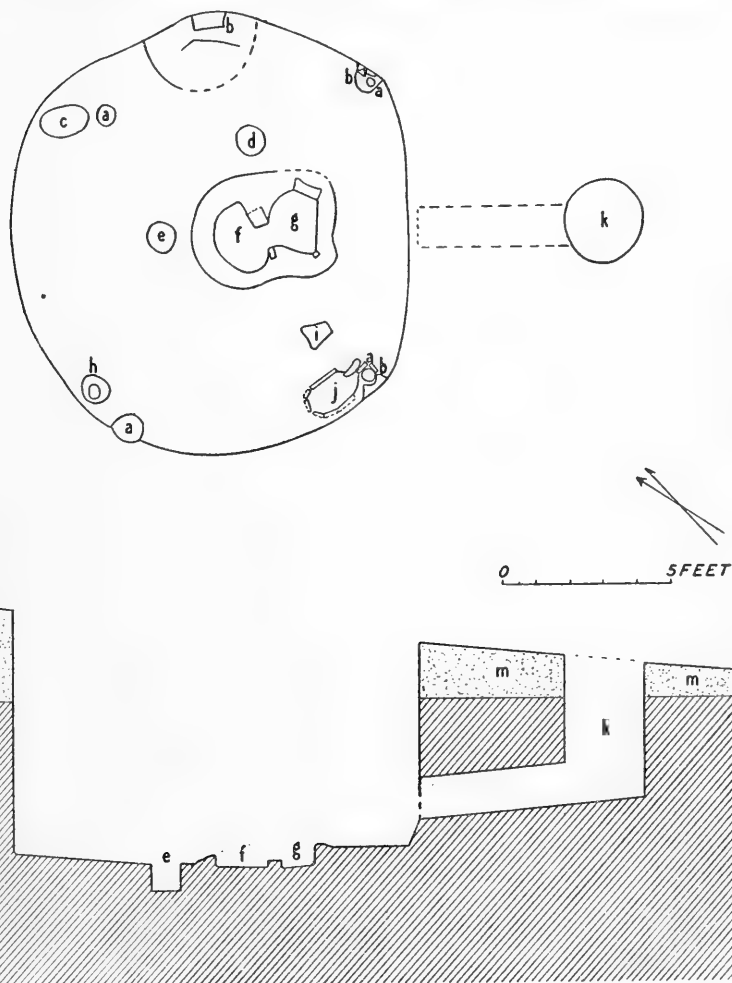
FIGURE 6.—Structure 3. *a*, support posts for superstructure; *b*, pilasters; *c*, storage basin; *d*, storage hole; *e*, sipapu; *f*, fire pit; *g*, ladder box; *h*, storage hole; *i*, stone embedded in floor; *j*, secondary fire pit; *k*, ventilator shaft; *m*, sand accumulation above old surface.

The superstructure was supported by four posts set in the floor and one pilaster or masonry pillar. Two of the support posts had been braced with mud plaster placed between them and the wall in the same fashion that the post in No. 2 had been buttressed (pl. 7, *b*). One curious factor in this connection is that in both Nos. 2

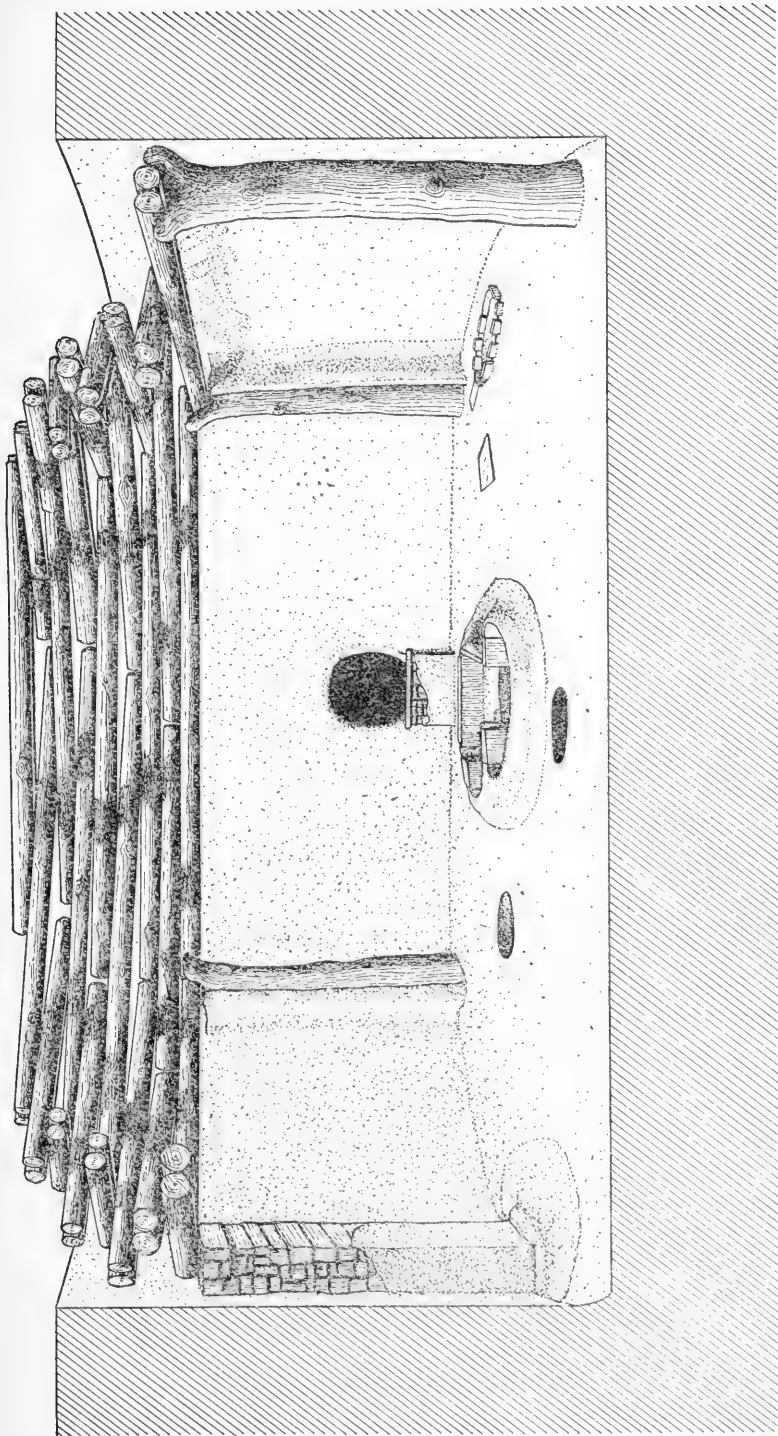
FIGURE 7.—Postulated reconstruction of cribbed roofing erected over pit of structure 3. One side removed to show method of laying timbers.

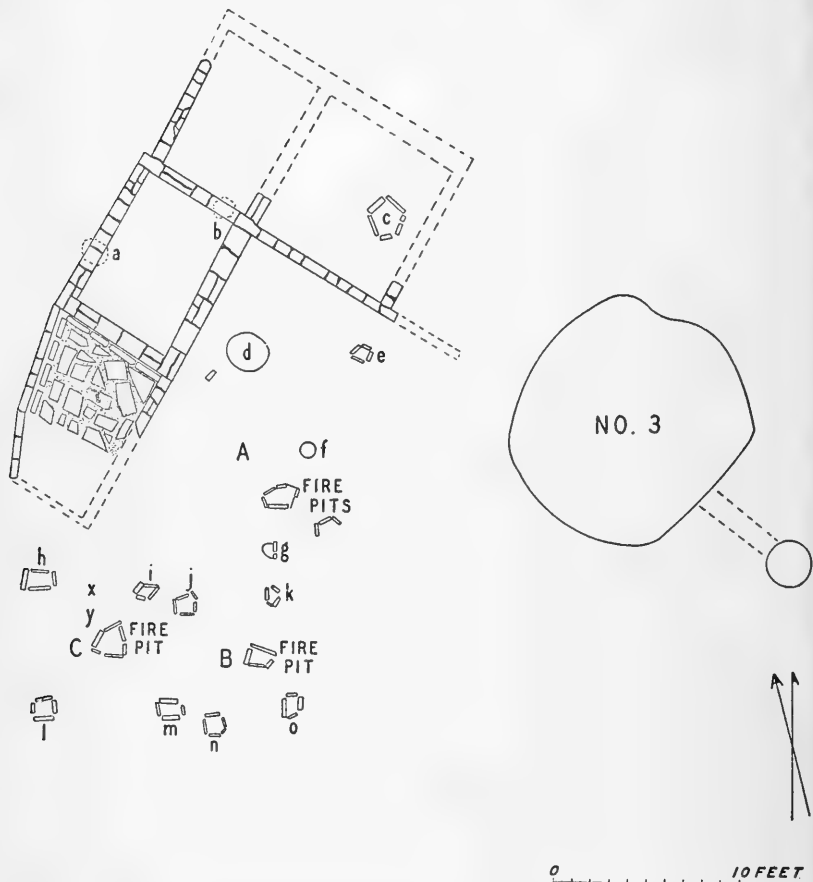
FIGURE 8.—Remains of surface building A. *a* and *b*, fire pits beneath foundations; *c*, fire pit in floor of room; *d*, opening into pit oven; *e*, *f*, and *g*, placements for portico posts; *h*, *i*, *j*, *k*, *l*, *m*, *n*, and *o*, placements for shelter posts; *x*, location of fragment of child's skull; *y*, location of black-on-white bowl.

extended across former fire pits (fig. 8, *a*, *b*). At the time the structure was built these pits were apparently on or just below the existing level of occupation. They were filled with stones and mud before the wall was carried across them (pl. 8, *a*). Another feature, that of a porch or portico, was indicated by the row of post molds or holes along the front of the structure. A similar feature was found near house 15 and inasmuch as the latter exhibited better the

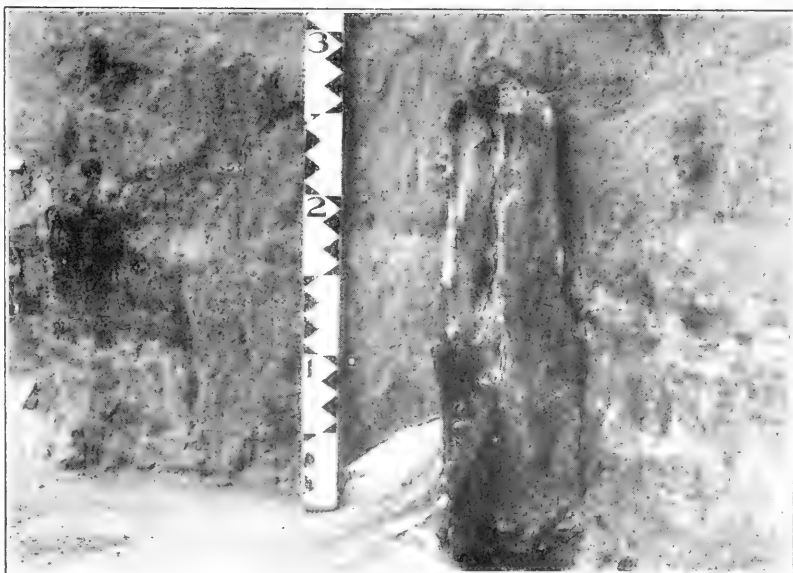
b. Plaster pilaster behind wooden roof support in structure 3.

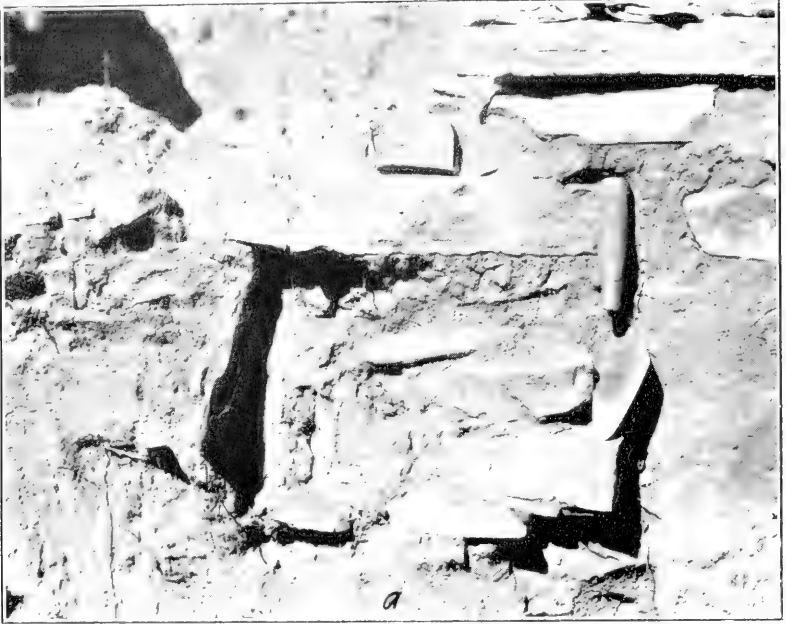
a. Fire pit beneath wall of surface structure A.

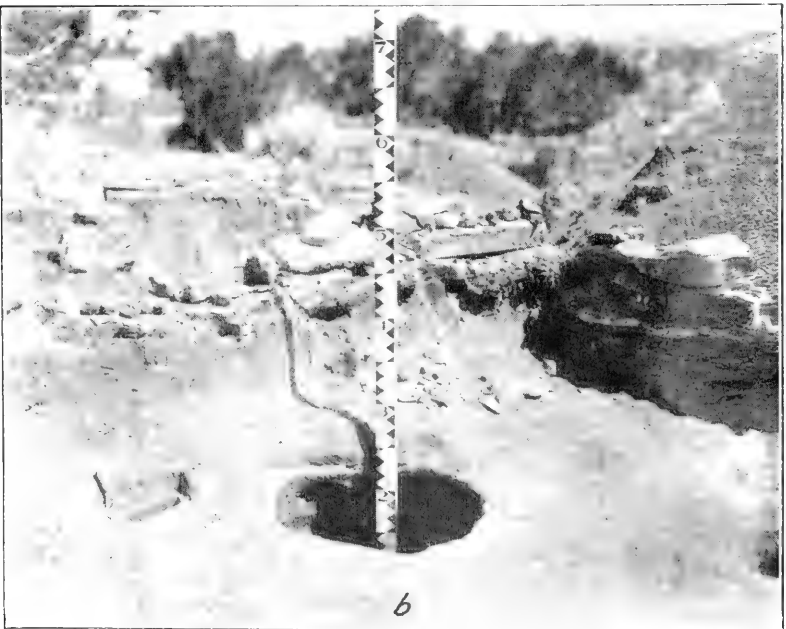
b. Opening into pit oven. Trowel indicates line

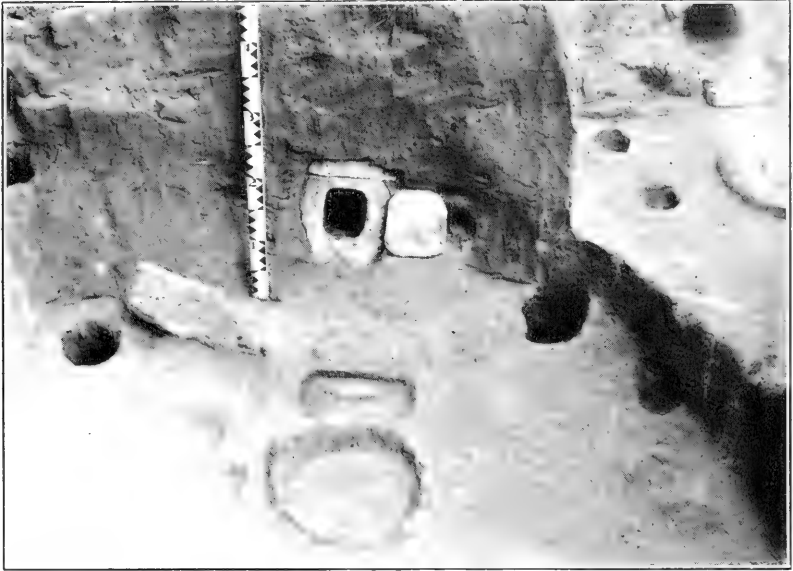
a. Stone ventilator aperture in structure 6.

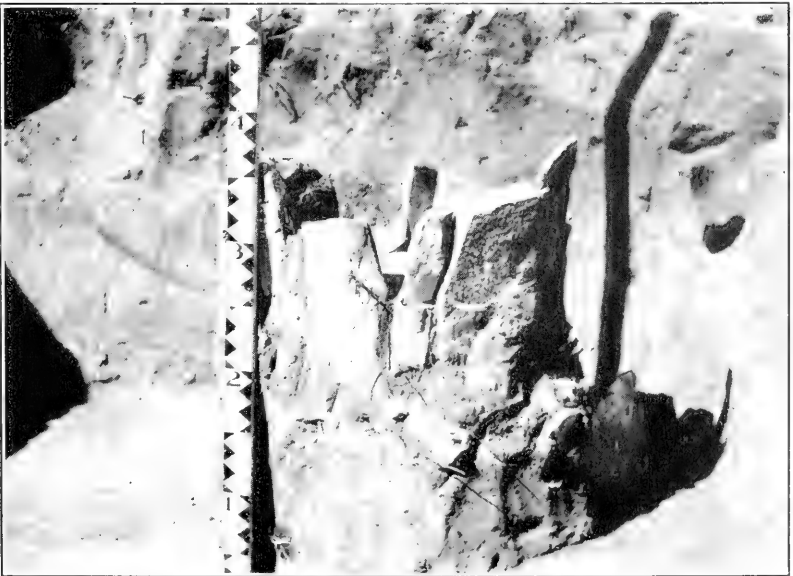
b. Fire pit in fill of structure 6.

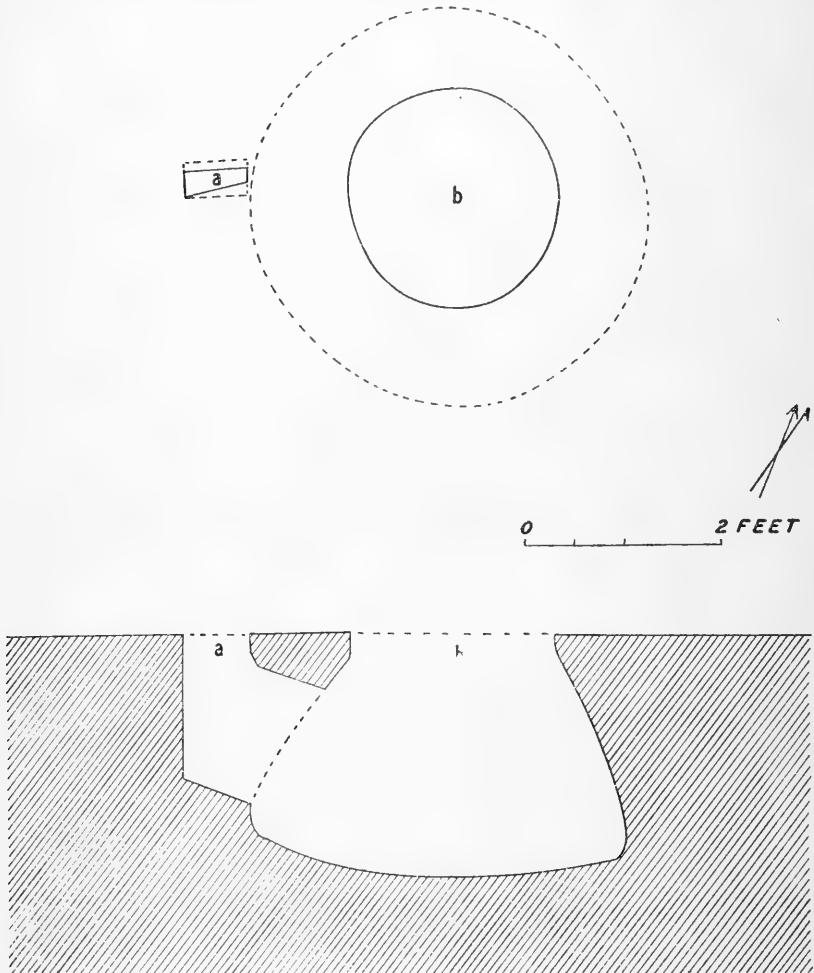
FIGURE 9.—Pit oven. *a*, flue; *b*, opening on ground level.

There was a slight difference between the example found on the Zuñi Reservation and that uncovered at this location. In the Zuñi pit the flue was oval to circular in form. It sloped obliquely upward and its outer end opened on the surface some distance from the main aperture of the oven.³² The flue of the oven in the court of Surface

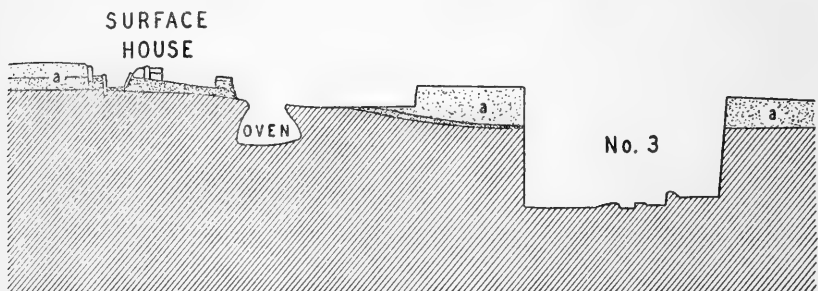
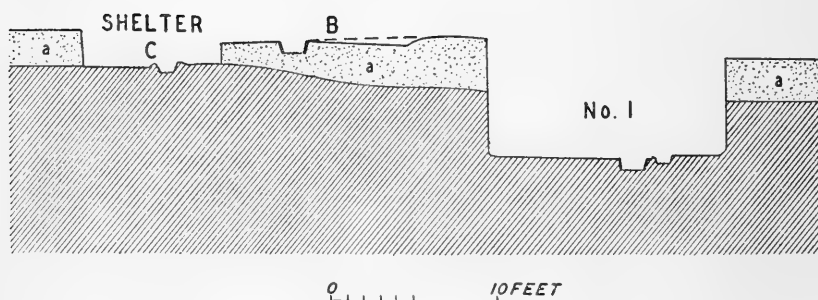
FIGURE 10.—Sections through surface remains A, pit oven and structure 3, shelter and structure 1. *a*, accumulation of sand above original surface of occupation.

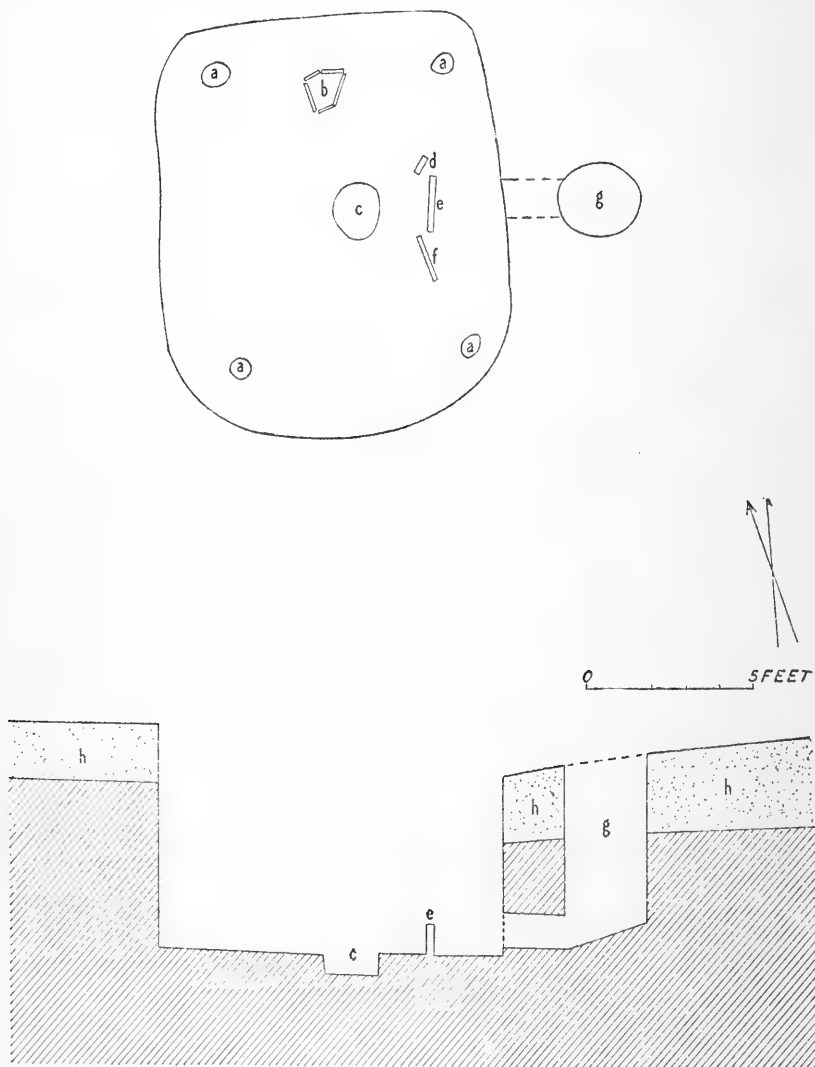
FIGURE 11.—Structure 4. *a*, holes for main support posts; *b*, storage box in floor; *c*, fire pit; *d*, standing stone; *e*, deflector; *f*, standing stone; *g*, ventilator shaft; *h*, sand accumulation above original surface.

No. 4 had a diameter of 10 feet 4½ inches (3.162 m) on the line through the ventilator and fire pit. Across the other way it measured 12 feet 9½ inches (3.898 m) from wall to wall. At the ventilator side the original depth of the pit was 3 feet 5½ inches (1.054 m). There

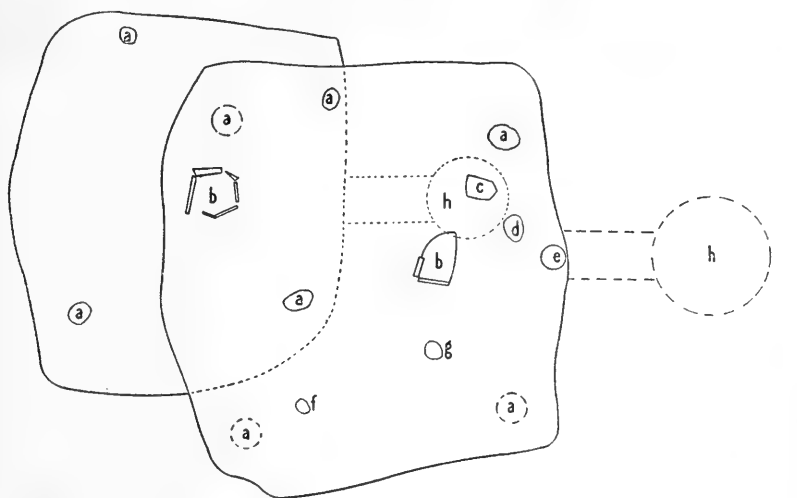
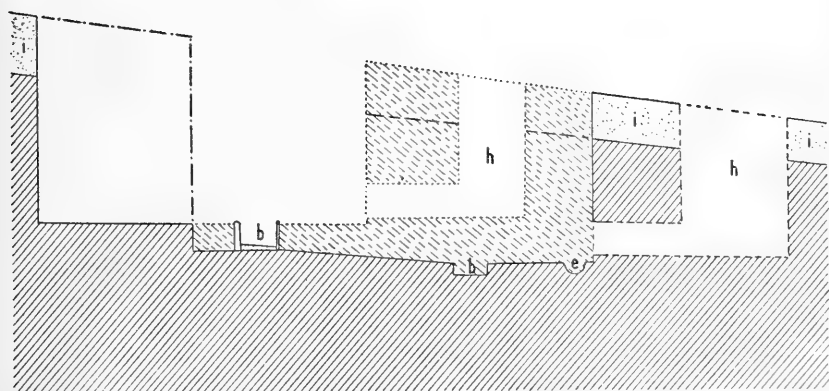
FIGURE 12.—Structures 5a and 5b. *a*, holes for main superstructure supports; *b*, fire pits; *c*, stone embedded in floor; *d*, basin in floor; *e*, hole in floor; *f* and *g*, storage holes; *h*, ventilator shaft; *i*, sand accumulation above old surface.

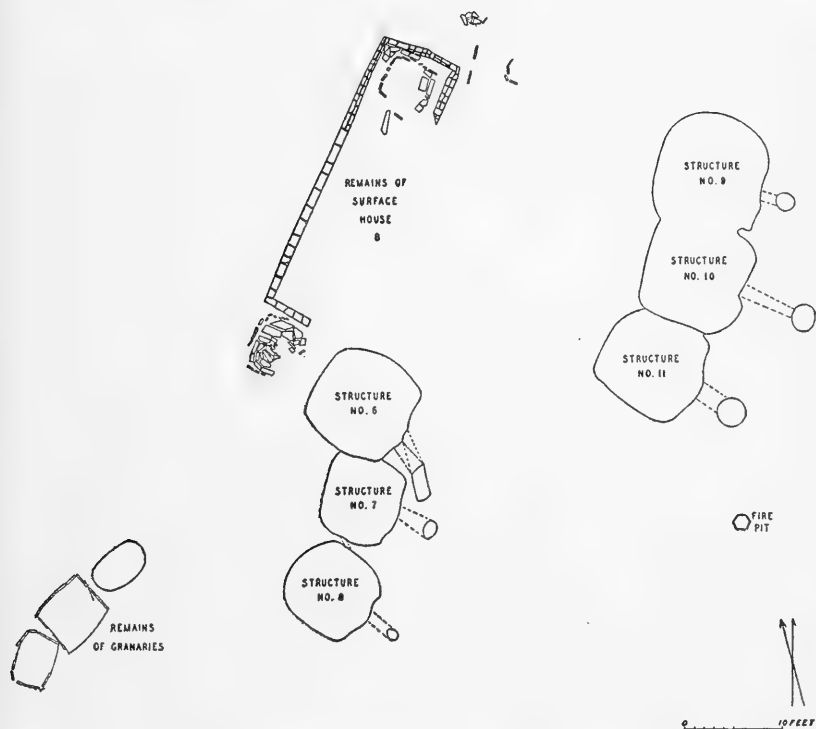
FIGURE 13.—Surface structure B and associated pit remains.

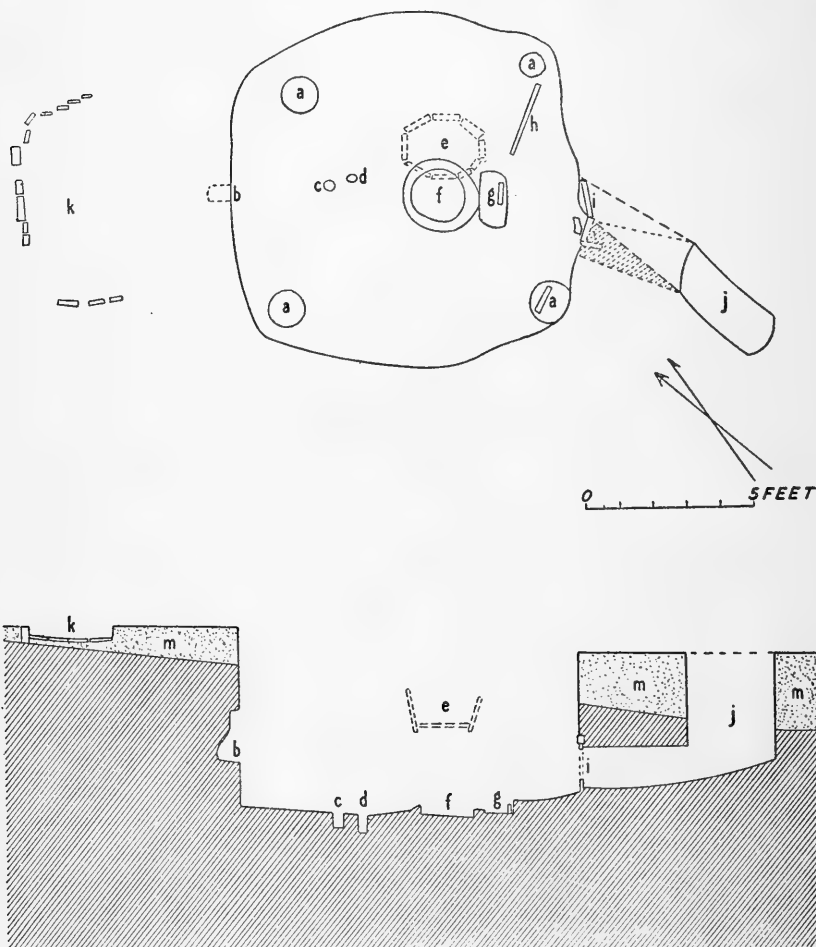
FIGURE 14.—Structure 6. *a*, holes for main roof supports; *b*, placement for roof brace; *c*, storage hole; *d*, sipapu; *e*, fire pit in fill; *f*, fire pit for fire; *g*, ladder pit; *h*, stone forming bin; *i*, ventilator stone; *j*, ventilator shaft; *k*, remains of granary; *m*, sand accumulation above old surface.

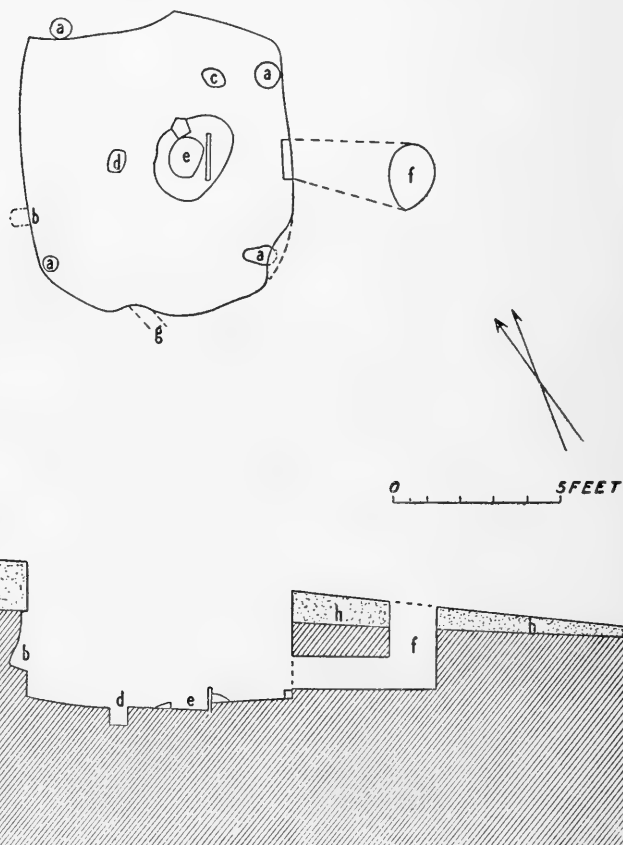
FIGURE 15.—Structure 7. *a*, holes for main support posts; *b*, placement for brace; *c*, storage hole; *d*, sipapu; *e*, fire pit; *f*, ventilator shaft; *g*, opening into 8; *h*, accumulation above original surface.

near the center of the chamber and at the north side of the fire pit a small storage hole (fig. 15).

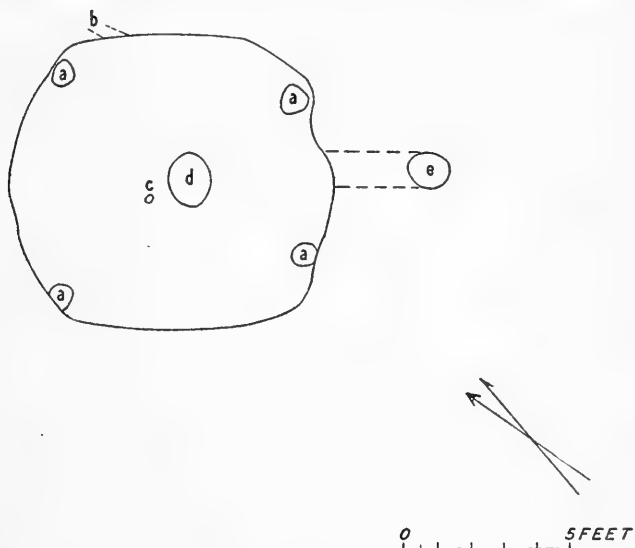
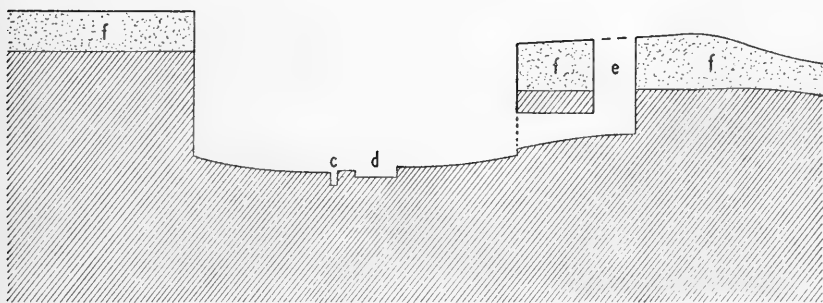
FIGURE 16.—Structure 8. *a*, holes for main supports; *b*, opening into 7; *c*, sipapu; *d*, fire pit; *e*, ventilator shaft; *f*, recent accumulation of sand above original surface.

The slitlike opening in the wall between structures 7 and 8 was larger in No. 8 than it was in No. 7. The width at the side of the wall was 9 inches (22.86 cm) and the height 2 feet 10 inches (86.36 cm). The greater height was made possible because of the fact that the floor of room 8 was $3\frac{1}{2}$ inches (8.89 cm) lower than that in room 7.

The ventilator opening was 1 foot 1 inch (33.02 cm) wide and 1 foot $11\frac{1}{2}$ inches (34.29 cm) high. The sill of the opening was $2\frac{1}{2}$

inches (6.35 cm) above the floor. The passage was 2 feet $3\frac{1}{2}$ inches (69.85 cm) long and where it entered the shaft was 1 foot 3 inches (38.1 cm) and 1 foot $\frac{1}{2}$ inch (31.75 cm). At the passage side its original depth was 1 foot $4\frac{1}{2}$ inches (41.91 cm), which was increased to 2 feet 11 inches (88.9 cm) by the sand drift. At the back of the shaft the original depth was 1 foot 4 inches (40.64 cm) and that at the time of excavation 2 feet $10\frac{1}{2}$ inches (87.63 cm).

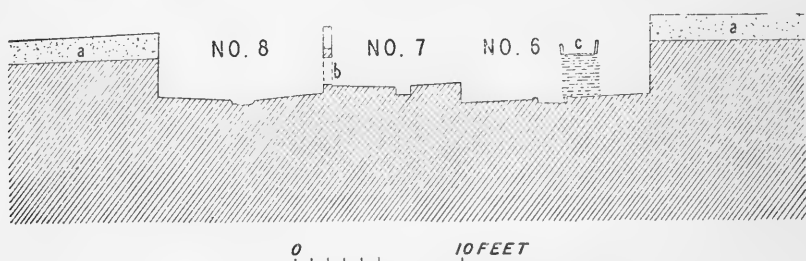
FIGURE 17.—Section through 6, 7, and 8. *a*, sand accumulation above original surface; *b*, opening between 7 and 8; *c*, fire pit built on fill in structure 6.

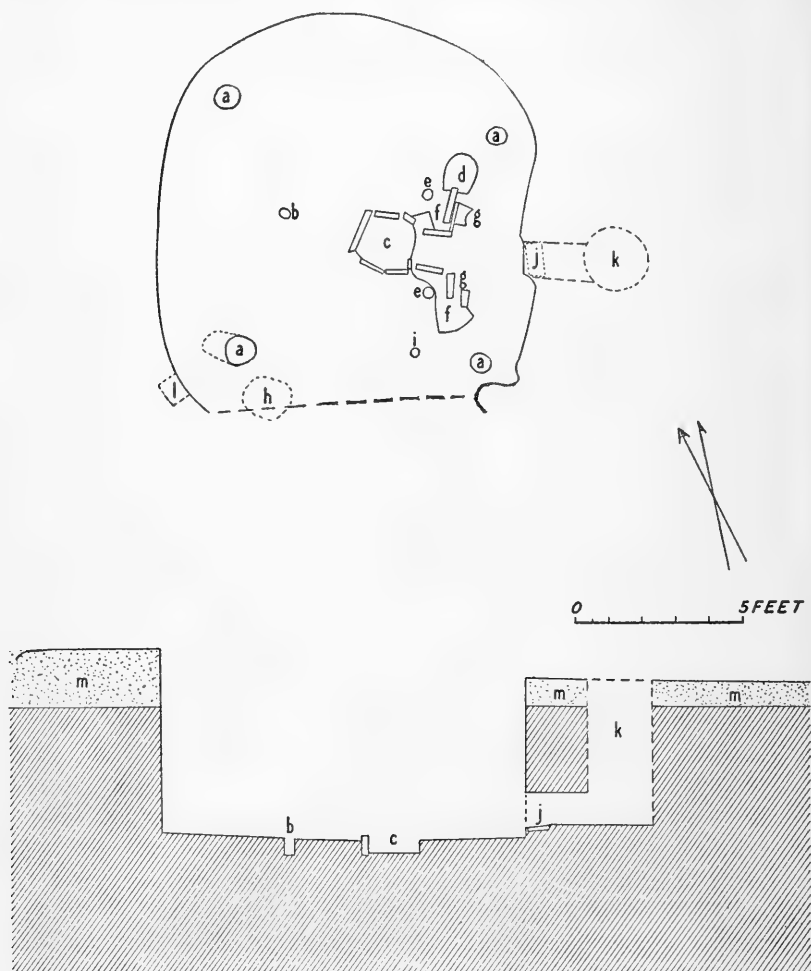
FIGURE 18.—Structure 9. *a*, holes for main support posts; *b*, sipapu; *c*, fire pit; *d*, fallen stone from compartment wall; *e*, holes for small poles; *f*, adobe plaster placement for compartment wall slabs; *g*, stones in compartment wall; *h*, location of support post for superstructure over 10; *i*, storage hole; *j*, ventilator opening and sill; *k*, ventilator shaft; *l*, placement for roof brace; *m*, sand accumulation above old surface.
